Intel[®] Mobile Pentium[®] II Processor Specification Update

Release Date: November 2000

Order Number: 243887-026

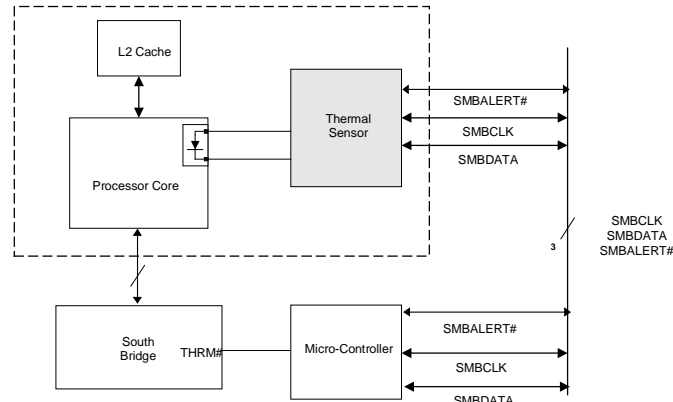
Figure 1. An Example of Microcontroller Driven Thermal Management

B30. Thermal Sensor May Assert SMBALERT# Incorrectly

Problem: The Mobile Pentium II processor and the Pentium II Processor Mobile Module have a thermal sensor that monitors the processor core's temperature. Please note that desktop systems could have a similar thermal device. The thermal sensor asserts SMBALERT# if the processor temperature exceeds the temperature limits set in the Alarm Threshold Registers (T_{HIGH} , T_{LOW}). It also sets the corresponding Status Register bits to identify the cause of the interrupt. Figure 1 gives one example of the how the SMBALERT# signal could be used in a system.

Under the conditions described below, the thermal sensor incorrectly generates the SMBALERT# interrupt. All of the following conditions must be met to trigger a false interrupt:

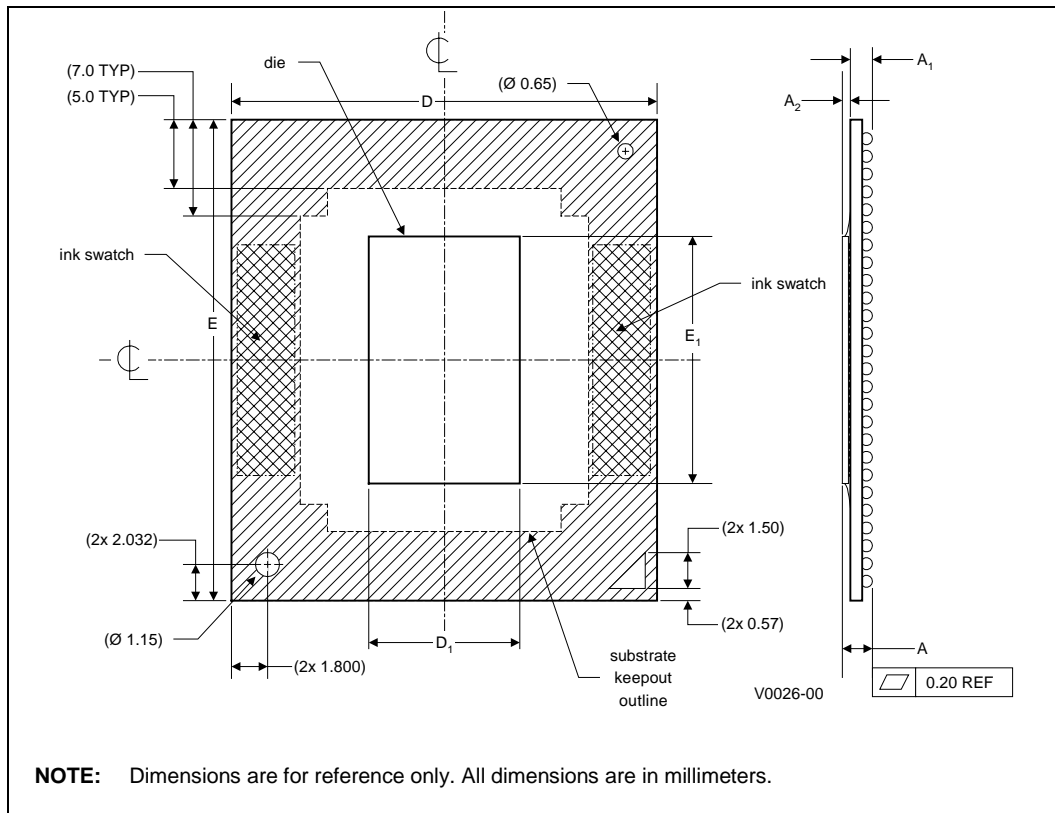
Figure 5.3. Surface-Mount BGA1 Package—Top and Side View

The following table and figures show the updated mechanical specifications for the BGA1 package, listed as Table 5.2, Figure 5.3 and Figure 5.4, respectively, in the *Mobile Pentium® II Processor in BGA Package at 366 MHz, 333 MHz, 300PE MHz, and 266PE MHz* datasheet.

1. The number shown here is different from that in the 243887-010 revision of this specification update. The maximum reference number is used.
